Hysham Notes for 2/10/2023

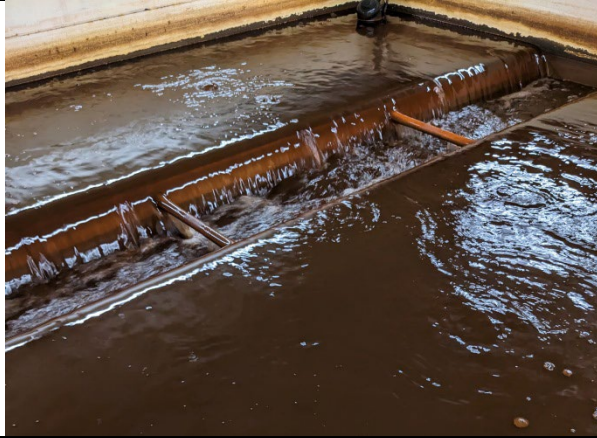
- We observed that the water leaving the bead chamber was very dark after the air scour and flush cycle was complete as shown in Figure 1. We decided it might be necessary to run the air-scour and flush cycle twice per day (every 3 hours) to prevent excessive buildup. The system appeared better after a second flush cycle as shown in Figure 2.

Figure 1 – Water leaving the bead chamber after air-scour and flushing.

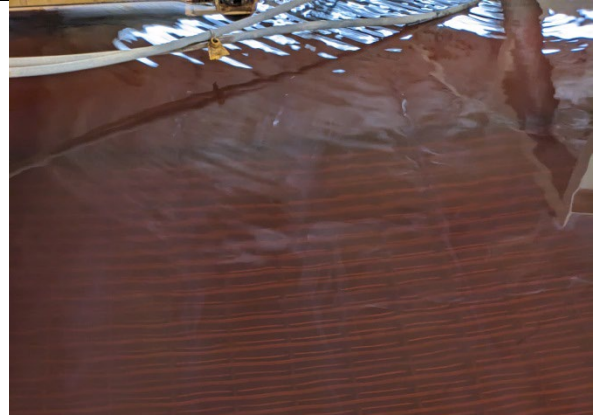
Figure 2 – Top of bead chamber after second flush.
