Hysham Notes for 2/16/2023.

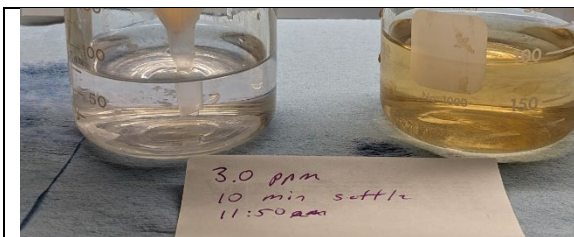
- We filtered about 100 ml of the 3.0 and 3.5 ppm solutions from the jar tests through 1.2 μm filter paper after settling for 10 minutes. The filtered water was clear from the 3.0 ppm permanganate jar as shown in Figure 3. The filtered water from the 3.5 ppm jar was slightly pink as shown in Figure 4 indicating there was more permanganate than could be reacted. This test indicated that the 3.0 ppm permanganate we were adding at the plant was near the optimum.

Figure 3 – Clear liquid after filtering 3.0 ppm permanganate jar after 10-minute settle.

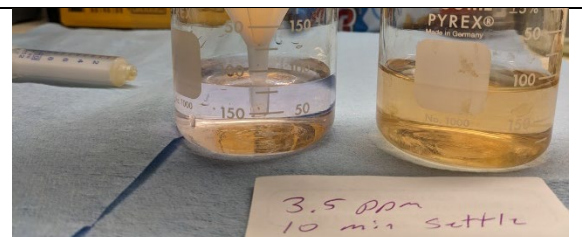
Figure 4 – Filtered liquid from the 3.5 ppm permanganate solution was a little pink. The solution faded but was still a little pink after 2 hours.

- We allowed the filtered samples to set for an extended time to see if there was additional iron or manganese that might be oxidized and turn the solution clear. The pink color did fade a little in 2 hours, but the sample was still pink indicating the bulk of the reaction happens within the 15 minutes mix/settle time we tested.

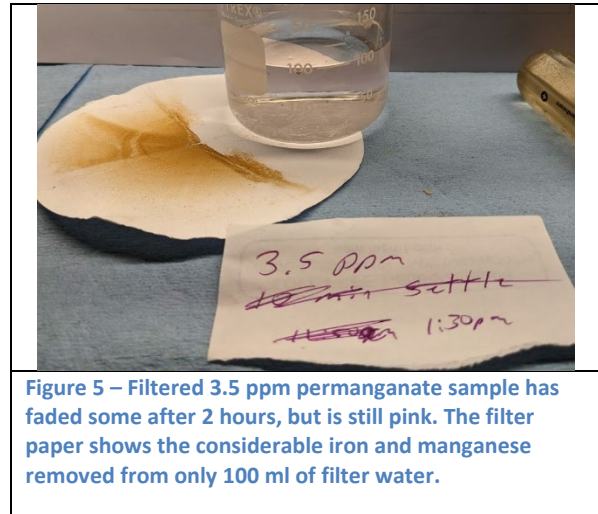
Figure 5 – Filtered 3.5 ppm permanganate sample has faded some after 2 hours, but is still pink. The filter paper shows the considerable iron and manganese removed from only 100 ml of filter water.
