(Plan in black / Notes in red)

**Our plan for Wednesday 3/1/2023 is to discuss the PLC and control system upgrade with Great West Engineering and a representative from In Control.** Boreal Controls sent me a copy of the PLC program. I have forwarded this to In Control to make a PDF copy that we can use to understand what the controller is supposed to do and how it needs to be improved.

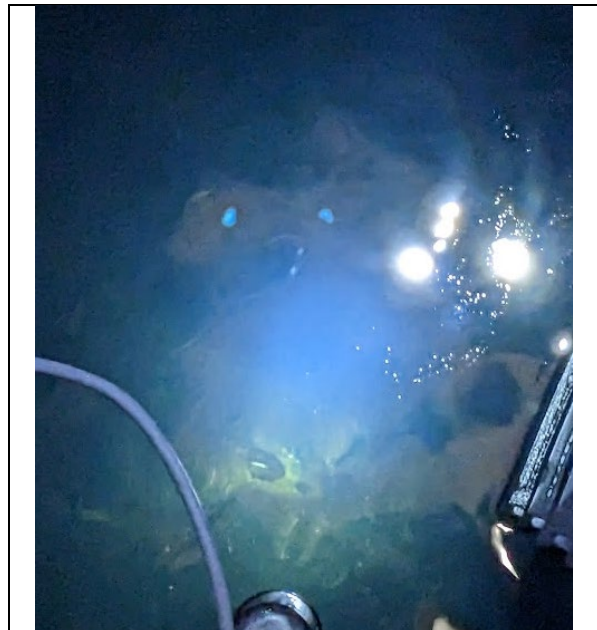
Figure 1 – Clearwell image showing dark material collecting on bottom.

We were not successful with the sludge judge because the valve was missing from the new sludge judge. We attempted to take photos of the bottom of the clear well as shown in Figure 1. The images are not very clear but show a dark material at the bottom of the clear well.

- The material at the bottom of the clear well looked like it could be anthracite filter media, but it isn't obvious that we are losing media based on a filter depth check. A depth check showed 47 inches from the top of the media in filter 1 to the top of the tank at several locations on the platform. This yields a media depth of 29.75 inches based on:
