## Hysham Notes for 3/10/2023

### Understand why the clear well effluent turbidity is not stabilizing.

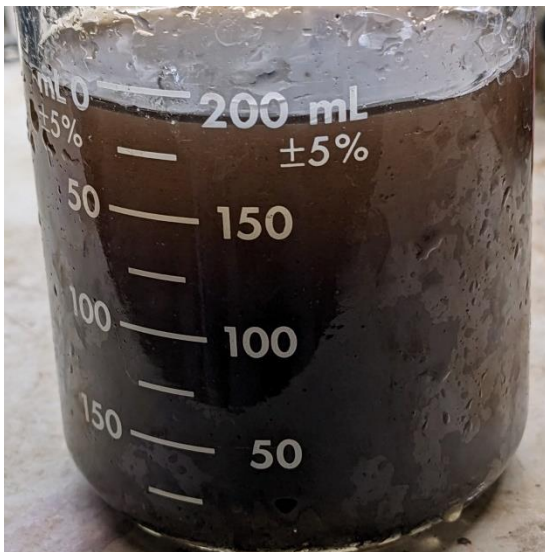
- We felt good about our progress today and think we have found plausible root cause for the elevated turbidity at the distributions system point of entry. It appears that a relatively thick layer of material at the bottom of the clearwell is causing the turbidity. The material is a mix of small pebbles, small black particles, and a dark brown flock. The flock is very light, is easily stirred up, and settles slowly. It seems like this light flock might be agitated in the clearwell by the influent and pump starts causing the turbidity increase in the clearwell. Images of the material collected from the bottom of the clearwell are shown in Figure 1 and Figure 2.

Figure 1 – Sample of material vacuumed off the bottom of the south clearwell.

- The material at the bottom of the clearwell included pebbles, small black particulates, and a light flock. The pebbles are presumed to be from aging concrete in the clearwell. The black particulates and flock are presumably precipitated iron and manganese. We attempted to reduce the precipitates using citric acid as shown in Figure 4 with a generous amount of citric acid. The acid did remove some color from the solution and may indicate reducing the oxidation state of suspended manganese and driving in into solution where it is clear. It is also possible

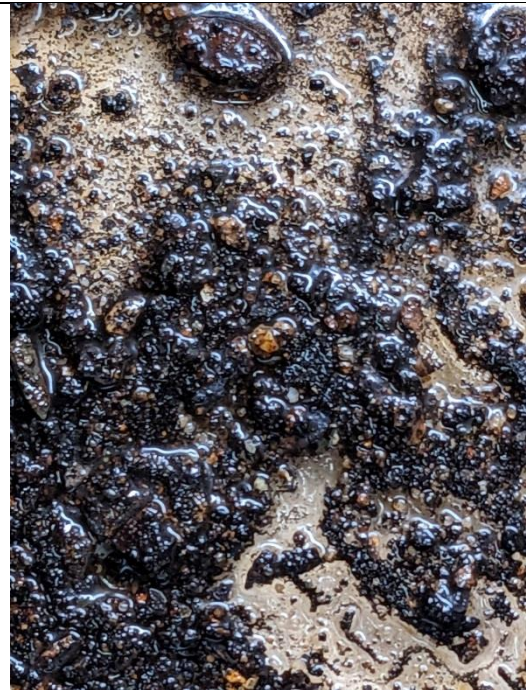
Figure 2 – Solids vacuumed off the bottom of the south clearwell after decanting fluid and lighter solids off. Material appears to be fine pebbles and dark particles.

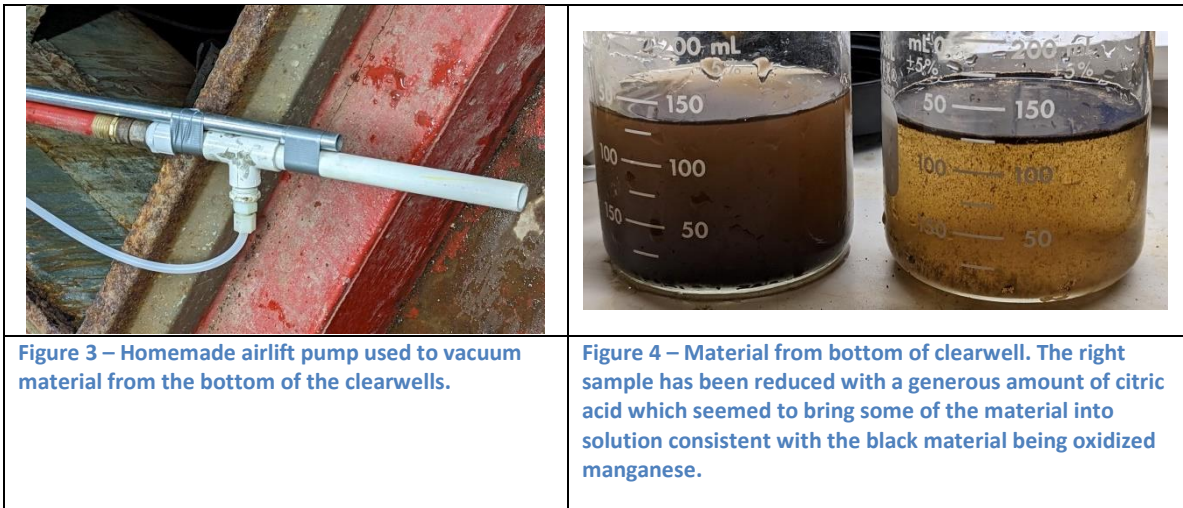
- Material was vacuumed off the bottom of the clearwells using a homemade airlift pump shown in Figure 3. We pumped a mix of water and solids from the bottom of the clearwells into a clean bucket. We could feel the layer of material at the bottom of the clearwell and very approximately estimate thicknesses. The south clearwell had maybe ½” of material at the bottom that had accumulated since cleaning in 2022. The north clearwell had maybe 3” of material that had accumulated since the 2017 cleaning.

Figure 3 – Homemade airlift pump used to vacuum material from the bottom of the clearwells.

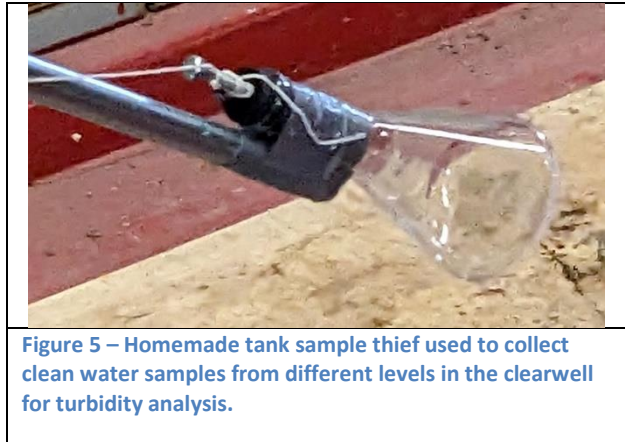
Figure 5 – Homemade tank sample thief used to collect clean water samples from different levels in the clearwell for turbidity analysis.

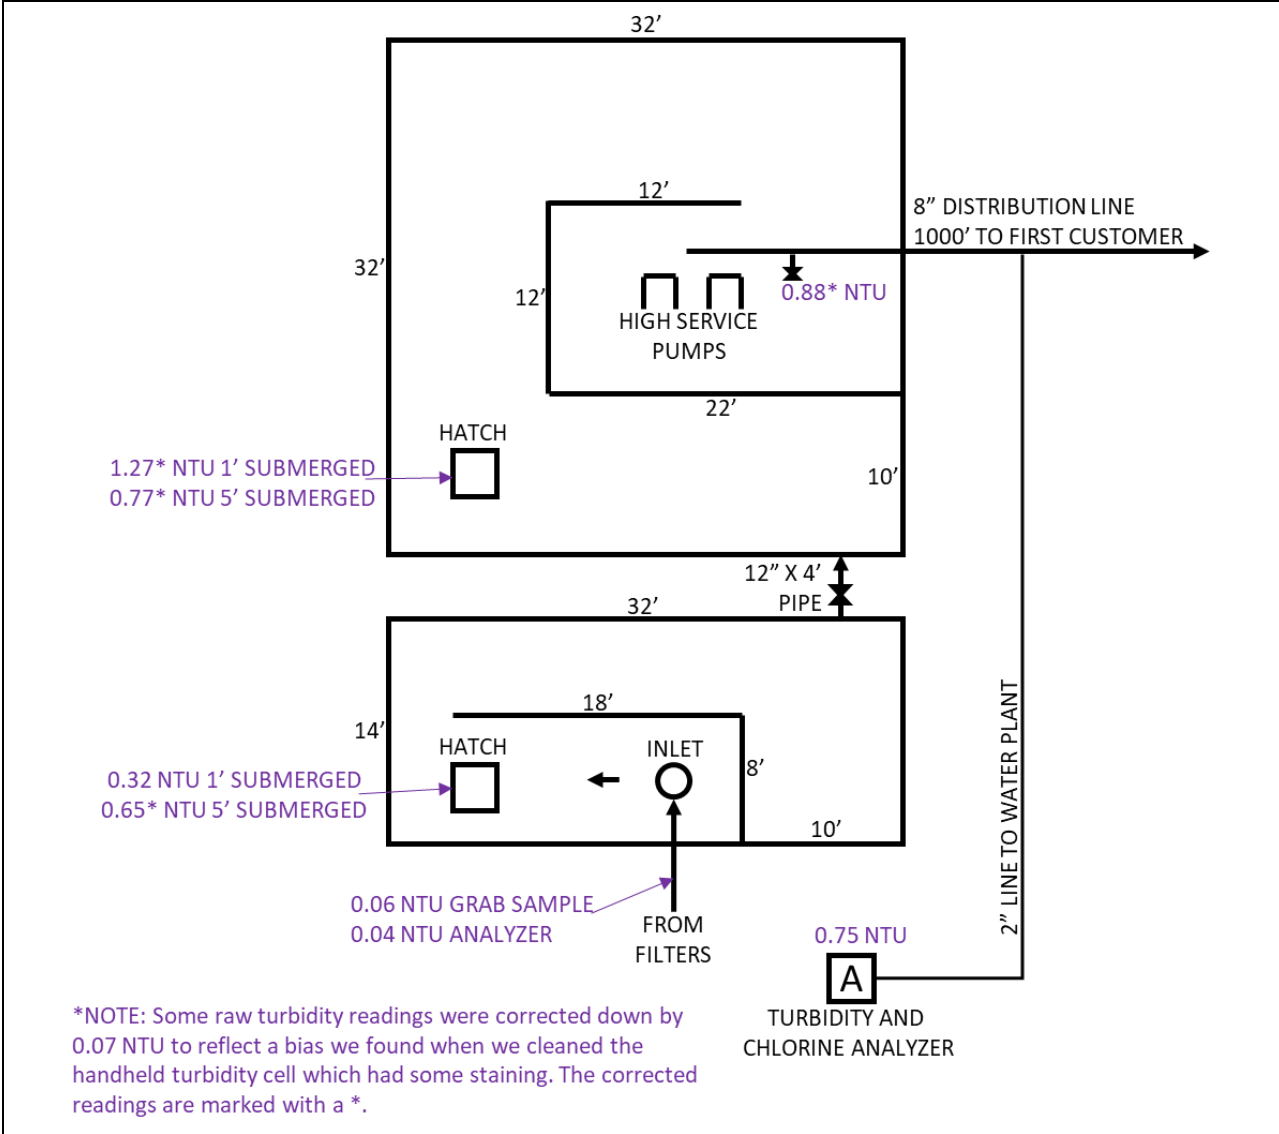
- We used a homemade tank sample thief shown in Figure 5 to collect clean water samples from different levels in the clearwell for turbidity testing. Result of the testing are documented in Figure 6 and showed a significant increase in turbidity as the filter effluent at 0.04-0.06 NTU entered the first clearwell and increased to 0.32-0.65 NTU. The turbidity further increased to 0.77-1.27 NTU in the second clearwell. Turbidity at the distribution system point of entry was 0.75-0.88 NTU measured by the analyzer and with a grab sample on the discharge of the high service pumps. This data seemed to support the theory that some of the turbidity observed at the distribution entry is being picked up in the clearwells.

Figure 6 – Clearwell configuration showing turbidity sample results and a rapid increase in turbidity when the clean filtered water enters the clearwell.
