# Town of Hysham

## Water System Preliminary Engineering Report Alternatives Presentation – September 27, 2023

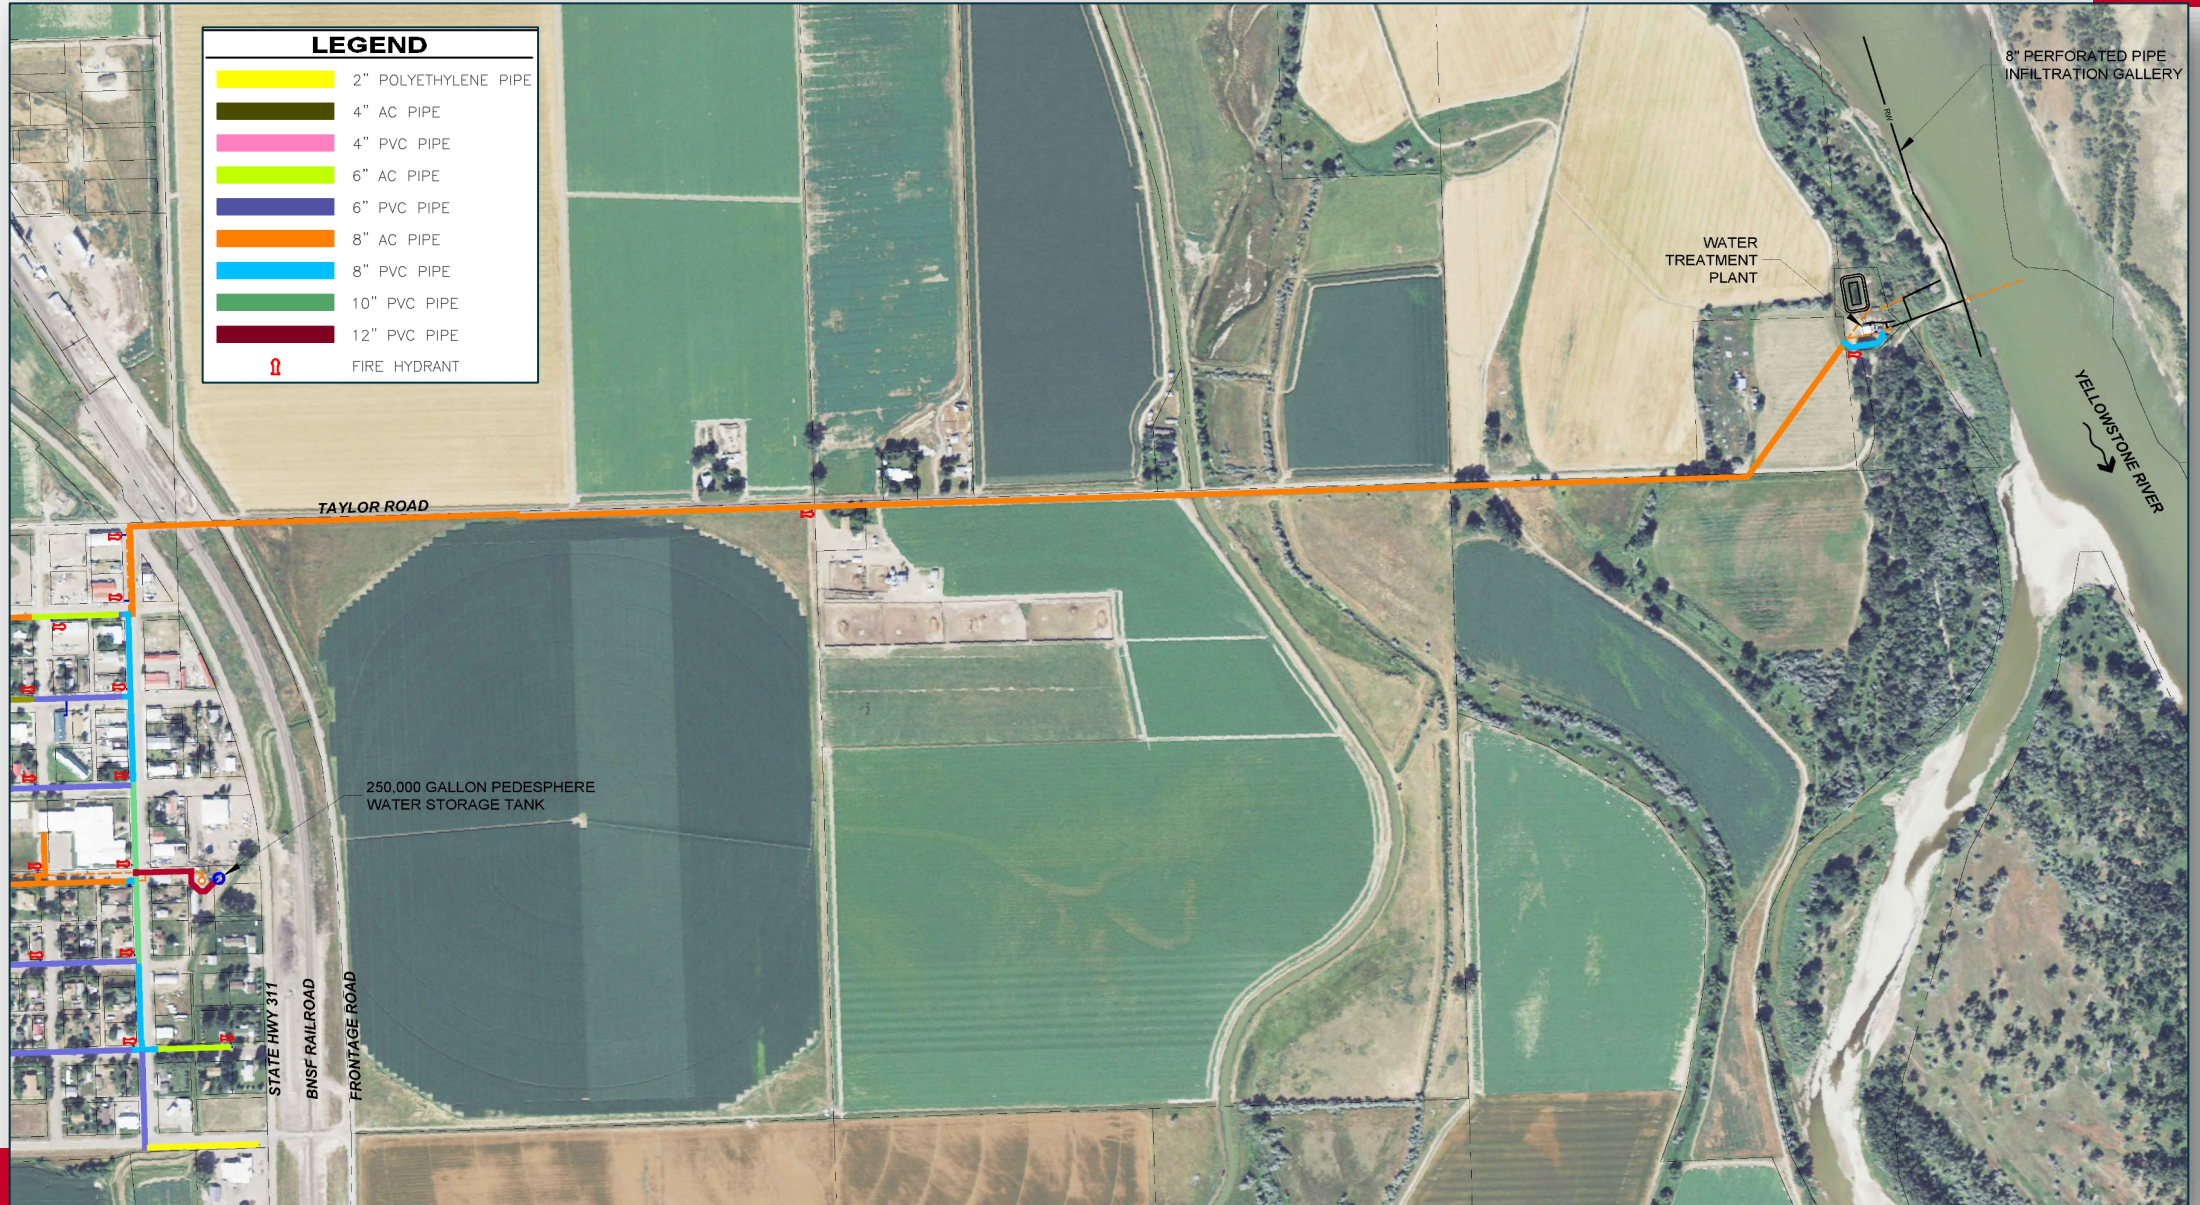
# EXISTING INFILTRATION GALLERY/TRANSMISSION MAIN

- Constructed in 1977
- Expanded in 2008
- Total of 1,500 feet
- Unknown pipe condition
- Manhole access has been damaged
- Inoperable valve
- Supply is mixture of surface water and groundwater
- High iron and manganese

- Replace manhole access
- Replace valve
- Perform video inspection

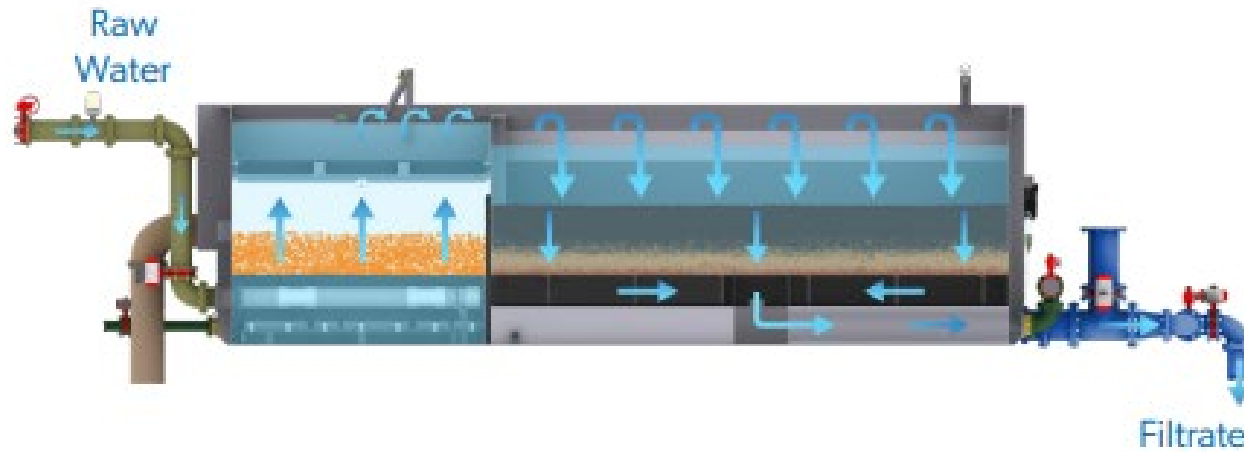
## Filtration Mode

The treatment process is started when chemically dosed raw water enters the Adsorption Clarifier near the bottom of the tank where an upflow treatment process combines flocculation and clarification. From the Adsorption Clarifier, flow continues over a weir into the collection trough where it is distributed into the mixed media filtration chamber, after which it is collected by the MULTIBLOCK® underdrain with Laser Shield™ media retainer and exits the tank.

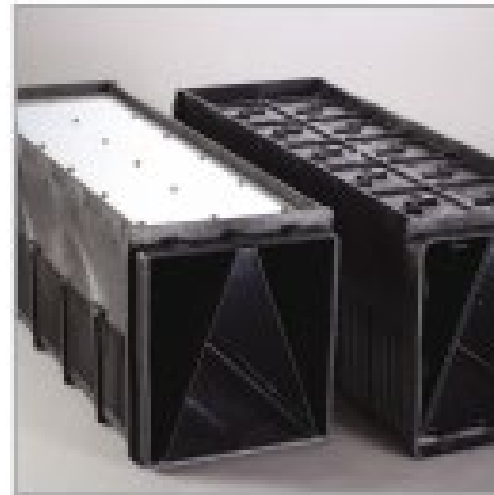
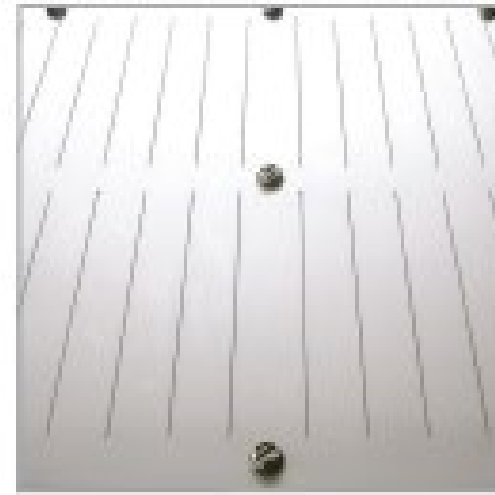
## MULTIBLOCK

MULTIBLOCK underdrains provide a high-quality, low-cost, engineered product that is economical and versatile. MULTIBLOCK underdrains are fitted with the unique Laser Shield media retaining system that eliminates the need for support gravel. Combined air and water backwash is provided using this system.

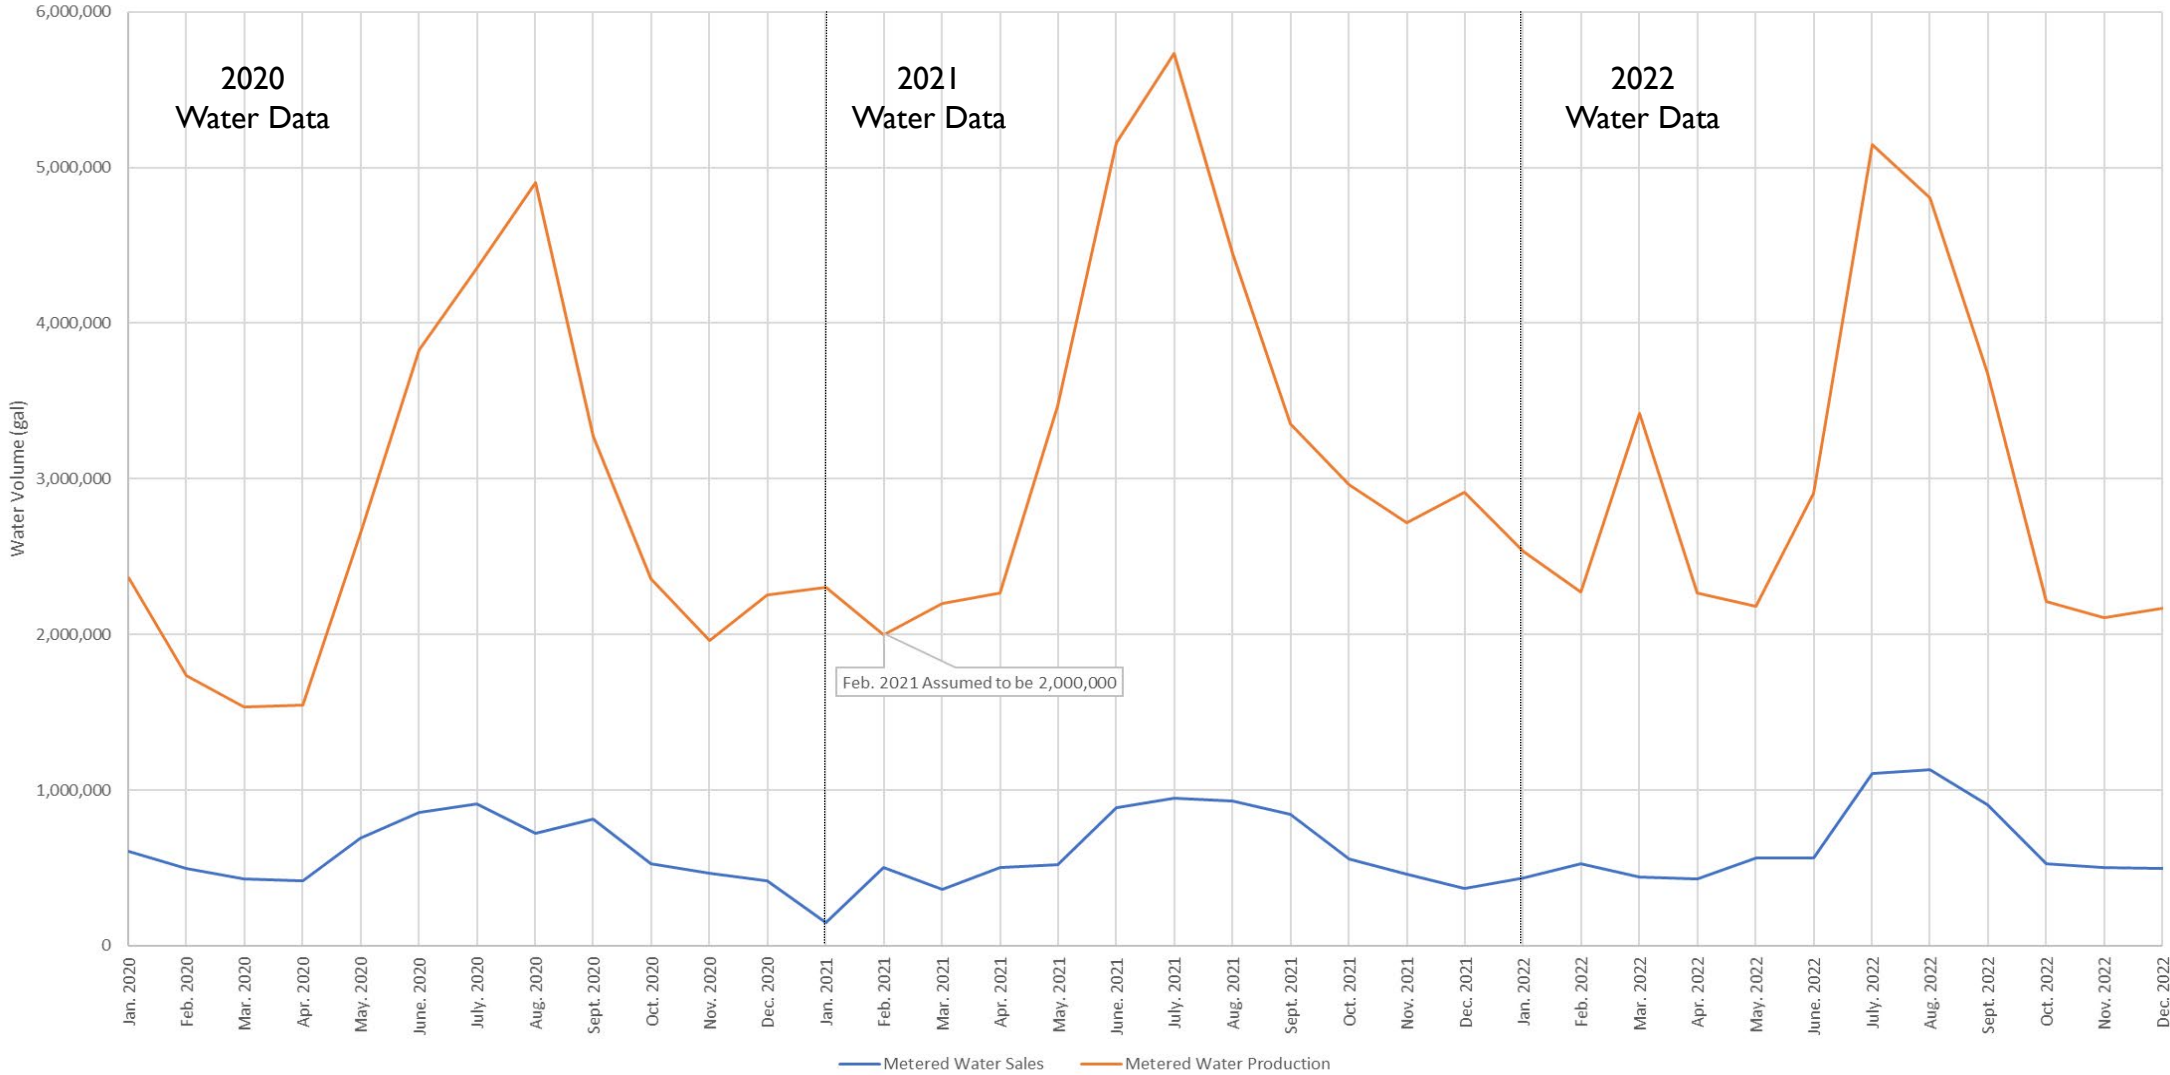
Metered Sales Vs. Metered Produced

Year	Production (gal)	Sold (gal)	Water Loss/ Not Sold (gal)	% Water Loss/ Not Sold
2020	32,762,393	7,358,861	25,403,532	77.5%
2021	41,525,673	7,034,676	34,490,997	83.1%
2022	35,700,432	7,632,198	28,068,234	78.6%
Average Yearly Produced (gal)	36,662,833			
Average Yearly Sold (gal)	7,341,912			
Average Yearly Lost (gal)	29,320,921			
Average % Water Loss/Not Sold	79.7%			
Population	275			
Average Water Usage (gpcd)	368
